GROUP <b>Product Improvement</b>	MODEL <b>See Model List on Page 1</b>
	NUMBER <b>PI1802W/X (Rev 2, 01/28/2018)</b>	DATE <b>October 2018</b>
<b>PRODUCT IMPROVEMENT CAMPAIGN</b>		
SUBJECT: <b>ENGINE REPLACEMENT INSTRUCTIONS FOR DTC P1326 (PI1802W/X)</b>

This bulletin provides information related to the Technical Service Bulletin previously published in July 2018 ([PI1802](#), Rev 5, 12/20/2018) titled “Knock Sensor Detection System - ECU Logic Improvement”. Specifically, this bulletin provides instructions on which procedures to follow if, after installation of the KSDS, any one of the subject vehicles below returns to the dealer with Diagnostic Trouble Code (“DTC”), P1326.

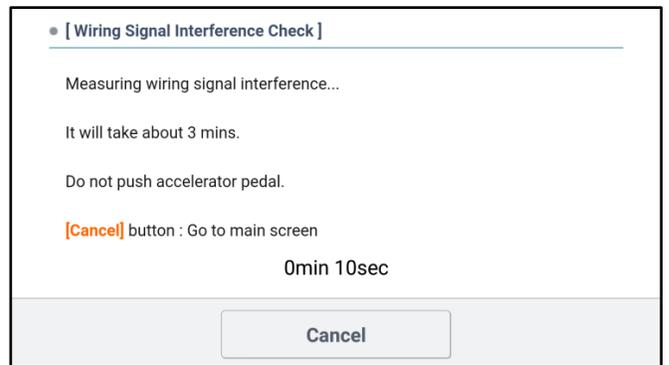
7. Wiring Signal Interference Check test will begin and take about three (3) minutes to complete. **NOTE:** Do not push on the accelerator pedal.

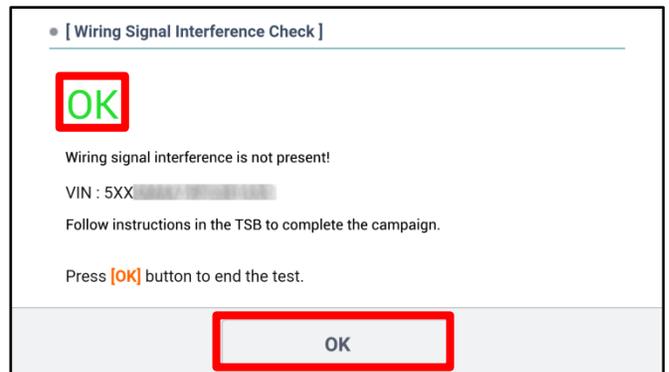
- If the result is “OK”, turn the engine off and proceed to the Engine Replacement procedure on page 10.

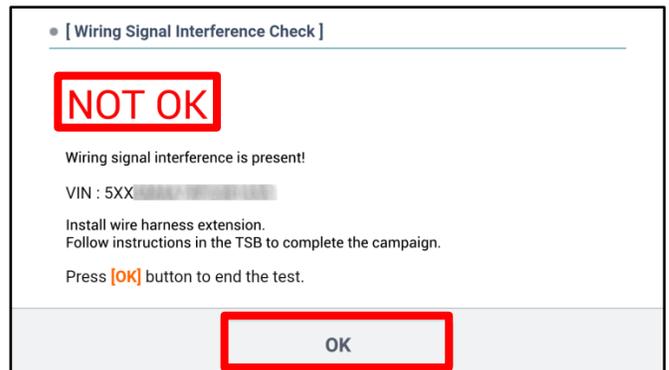
- If the result is “NOT OK”, turn the engine off and proceed to **step 2** of the Knock Sensor (KS) Extension Harness Installation procedure on page 5.

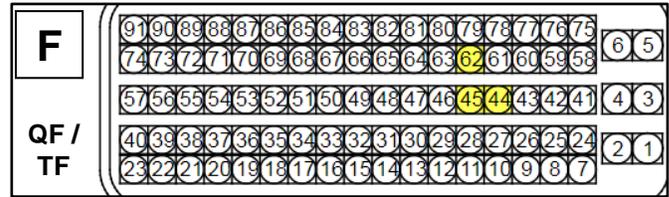
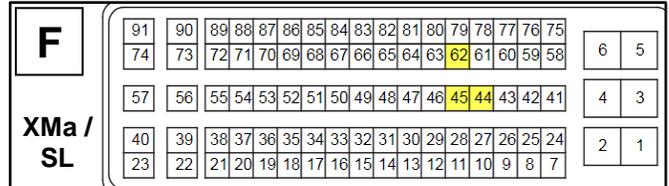
QF, TF, XMa, and SL	
Pin	Wire
44	Knock Sensor Shielded Ground
45	Knock Sensor Ground
62	Knock Sensor Interface (Signal)

8. Locate the three (3) knock sensor circuit terminals from the ECU connector (F). Refer to the “Schematic Diagrams → Engine Electrical System → Engine Control System → Schematic Diagrams” chapter of the applicable ETM on KGIS.

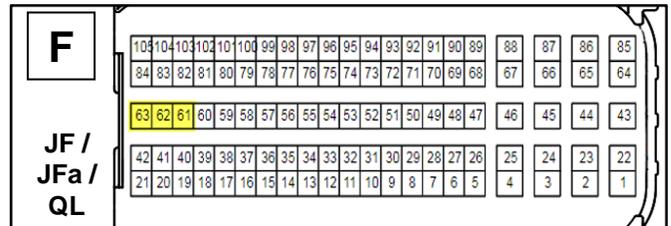
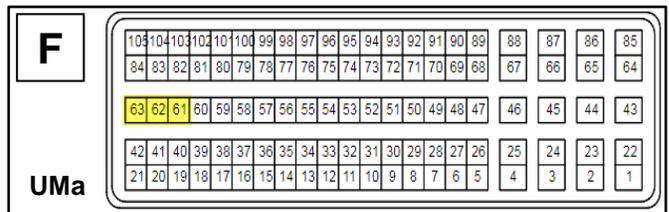
UMa, JF, JFa, and QL	
Pin	Wire
61	Knock Sensor Shielded Ground
62	Knock Sensor Ground
63	Knock Sensor Interface (Signal)

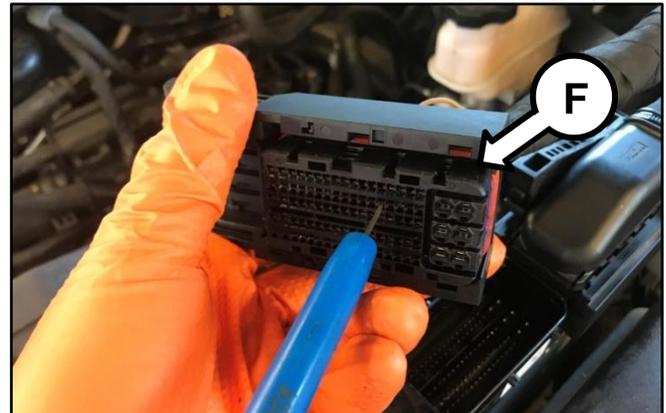
QF, TF, XMa, and SL	
Pin	Extension Wire Color
44	Blue
45	Black
62	Red

9. Remove the three (3) terminals **one at a time** and insert the new terminals of the extension harness into the ECU connector (F). Reinstall pin retainer (K) and reassemble the connector (F).

**NOTE:** Be sure to note the rotational position of the terminals during removal. They are directional and need to be reinstalled in the same “clock” position.
